Level playing field

Kevin Dare, managing director, FACE Consultants Ltd and a member of the Concrete Society working group on floor regularity, looks at the new flatness standards for concrete floors.

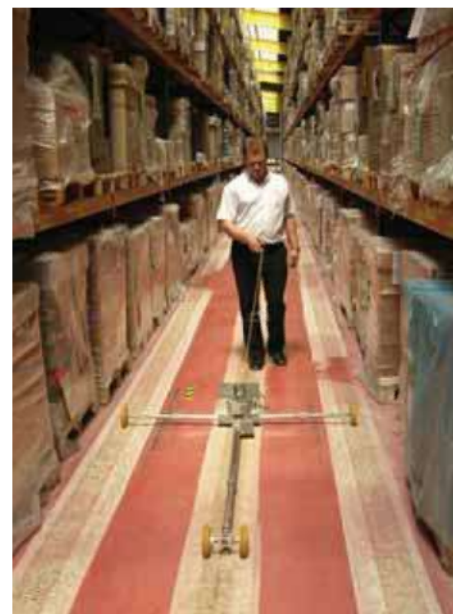
A Concrete Grinding operative using a profileograph to measure floor flatness.

TR34 edition 3 also proposes a new method for surveying defined movement areas, using a profileograph that simulates the dimensions of the trucks to be used. The profileograph produces a continuous profile of the floor surface in relation to the specification as it travels along the wheel paths of the lift truck, effectively recording the regularity of the floor as a truck would experience it.

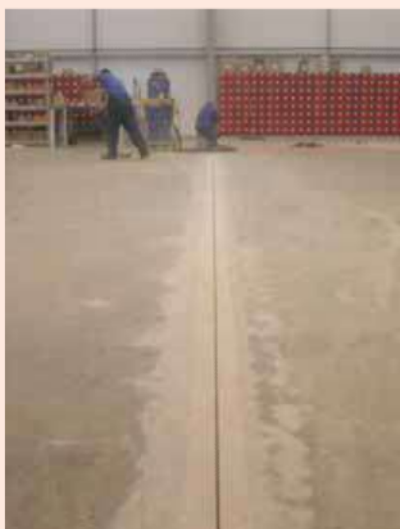
Uneven joints between the three sections of the floor slab in the warehouse at Milton Keynes run by furniture fittings distributor Blum UK Ltd were causing the wire-guided man-up trucks to frequently malfunction. CG (UK) confirmed that localised sub-base compression relating to the failure of the load transfer system between the slabs was the fundamental cause of the uneven joints. Originally Blum UK had considered carrying out

major structural repairs to the slabs, which would have taken at least six week-ends and been very disruptive and expensive. CG (UK)'s solution was to stabilise the joint edges by pumping a high-strength resin foam into the void beneath them, cutting back the joint arises to a depth of 50mm and then re-building the joints with a high-performance epoxy mortar. Finally, the joints were re-cut in the same position as before, filled with a semi-rigid compound, ground to ensure a completely even surface and sealed.
