# The Expert >>

## 8th Article - Repairs to Joints: Part 1 >>

In the last edition, I discussed the maintenance of joints with particular attention to joint sealants. In this article we will consider some of the basic issues of damage to joints and particularly with repairs to sawn joints..

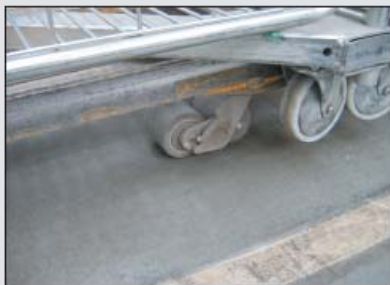
So why do joints get damaged? Most of the damage is caused by truck wheels, although some will be caused by careless scraping with pallets and truck forks. The hard wheels of pallet trucks and reach trucks are the worst offenders. See above picture. Generally, counter balance trucks, with their larger softer tyres are less of a problem. It is also relatively unusual to see much damage in very narrow aisles where turret trucks operate. Although they have similar tyres to reach trucks, wheels tend to be larger and as they run in straight fixed paths there are no

Joint arrises are subject to very high localized impact loads causing the concrete to spall and the wider the joint, the higher the potential impact as the wheels drop into the joint gap. It is therefore important to keep the gap as small as possible, although with joints that are moving, there is a lower limit because of the need to provide enough sealant to enable expansion and contraction to take place. When arrises are damaged, the joint gap inevitably gets larger giving greater potential for further damage. The deterioration process therefore accelerates and so it is important to nip damage in the bud.
